FRACTOGRAPHIC AND THERMAL ANALYSES OF SHOCKED ALUMINA

Technical Report 69-5

April 1969

MATERIALS RESPONSE PHENOMENA AT HIGH DEFORMATION RATES

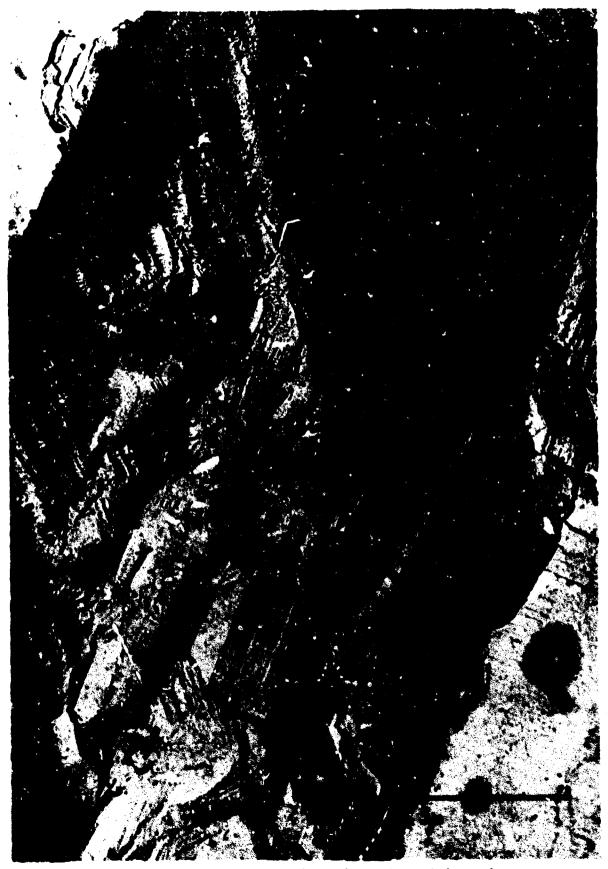
Figure 8. Transitions from cleaved (lower) to sheared (upper) regions in ballistically damaged sapphire, X15,000.

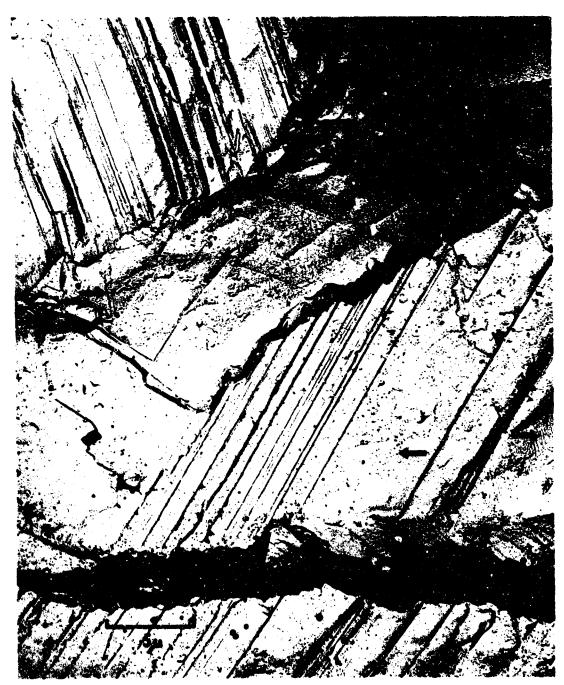
Figure 9. Fine textures associated with cleavage in ballistically damaged sapphire, X4,800.

Pt-C shadowed direct carbon replica [S11-1333]. Chemically stripped direct carbon replicas are quite brittle, and therefore are very unlikely to generate deformation artifacts. Hence, fine texturing (indicated by arrows) and deformed regions shown in this figure are indicative of localized plastic deformation associated with cleavage crack propagation.

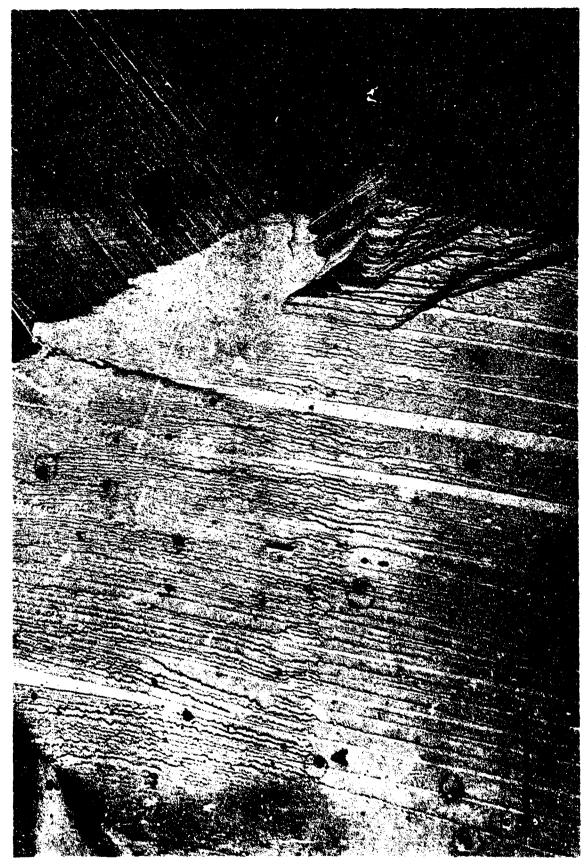
Figure 11. Abrupt transitions from straight to irregular cleavage steps in ballistically damaged sapphire, X28,400.
Pt-shadowed direct carbon replica [S12-1561]. Two examples are shown along lines A-A' and B-B'.

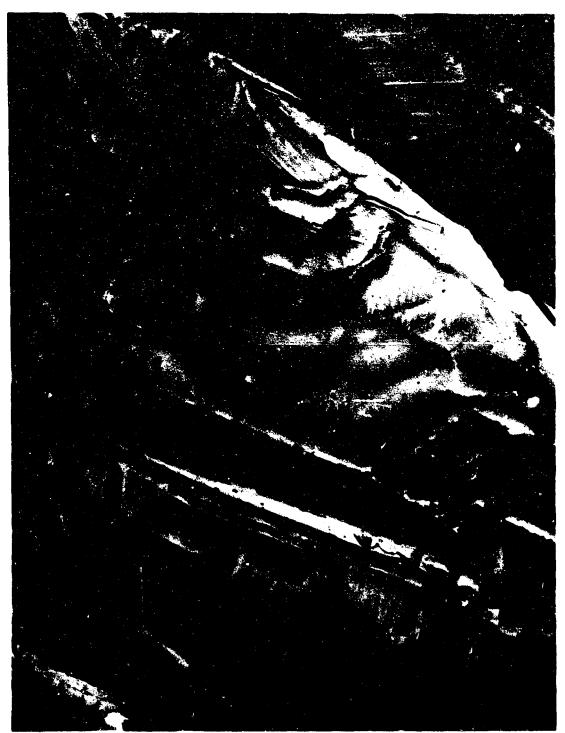
Figure 12. Transition from cleavage to more generalized plastic deformation in ballistically damaged sapphire, X12,200.

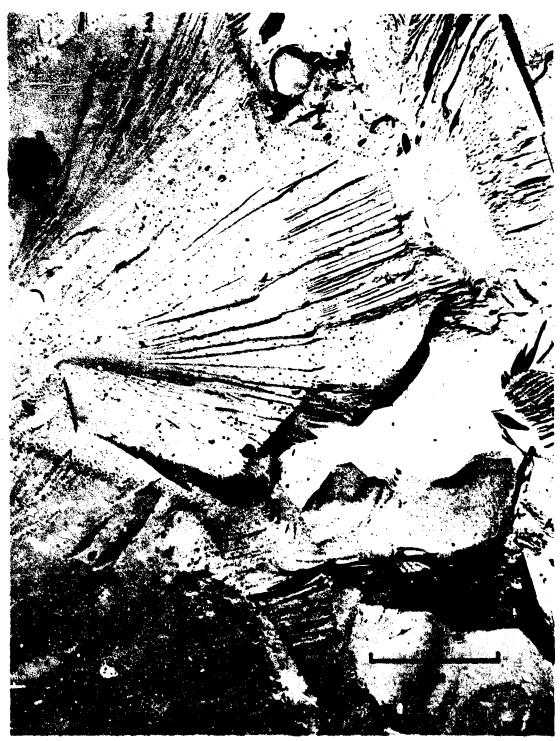
Very little of the principal conoid shear surface was available for study. The replicated surface was obliquely oriented (~ 45°) with respect to the impact trajectory (see Fig. 2d). Figure 13 illustrates several features characteristic of this heavily damaged surface. Fracture was predominantly transgranular, and was rather direct, producing relatively flat, fan shaped river patterns, some of which show multiplications of river pattern components as the fracture front traverses subgrain or grain boundaries. In many instances, progressions from one grain to the next appear to have required considerable shear damage before the crack could be

Figure 13. Complex fractography of conoid shear surface in ballistically damaged polycrystalline alumina tile, X6,900. Two-stage plastic-carbon replica, Pt-shadowed at 30° [D1-386].

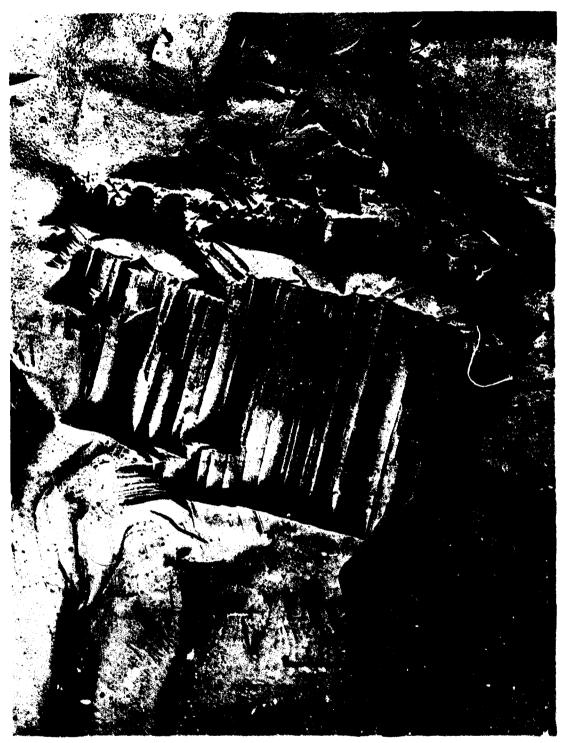
Rough Surfaces. As Figure 14 illustrates, heavily stepped fracturing based on intersections of two first order and one second order rhombohedral cleavage planes constitute one significant fracture mode in the rough portions of radial cracks, just as in the single crystal case previously described. Intergranular separations also have been observed to be quite prominent in the still incomplete investigation of this experimentally difficult fracture category. [Only scanning electron microscopy (combining moderate to high magnification, high resolution, and extreme depth of focus) is likely to provide adequate characteritations of such rugged but finely detailed surfaces.]

Figure 14. Heavy stepped cleavage fractures and intergranular separations on roughly textured portion of a radial crack in ballistically damaged polycrystalline alumina tile, X12,000. Two stage plastic-carbon replica, Pt-shadowed at 45° [SD3-601].

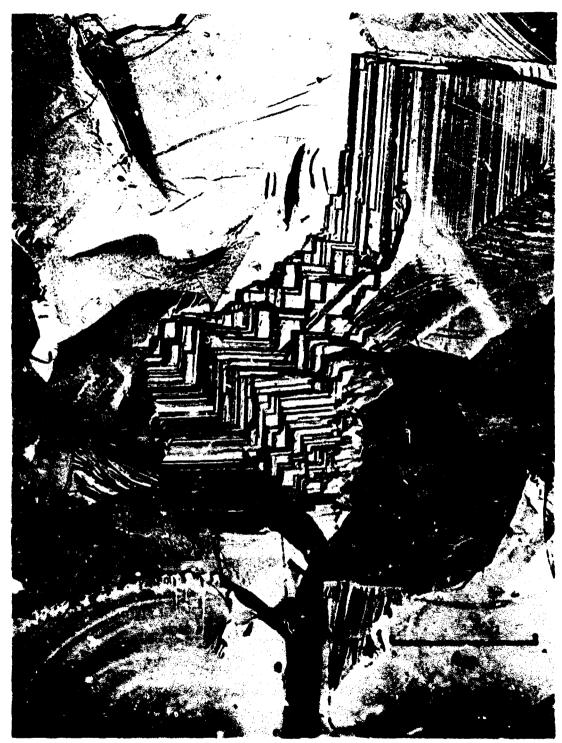
In Figure 15, conchoidal fractures, intergranular separations, two very characteristic forms of rhombohedral cleavage, and several examples of fracture fragment formation are illustrated. The central grain shows a very well defined shift from intergranular separation to transgranular cleavage. A similar case is shown near the center of Figure 16, where a small, relatively featureless region of favorably oriented grain boundary separated to advance the crack, but was surrounded by transgranular conchoidal fractures which were locally modified by cleavage and/or parting. In Figure 17, the long central boundary surface shows another transition from boundary separation on the right (which grades off into parting and conchoidal

Figure 15. Intergranular separations, transgranular cleavage steps, conchoidal fractures and in situ fracture fragments contribute to the very complex topography of a smoothly textured portion of a radial crack in ballistically damaged polycrystalline alumina tile, X9,600. Two stage plastic-carbon replica, Pt-shadowed at 30° [SD4-382].

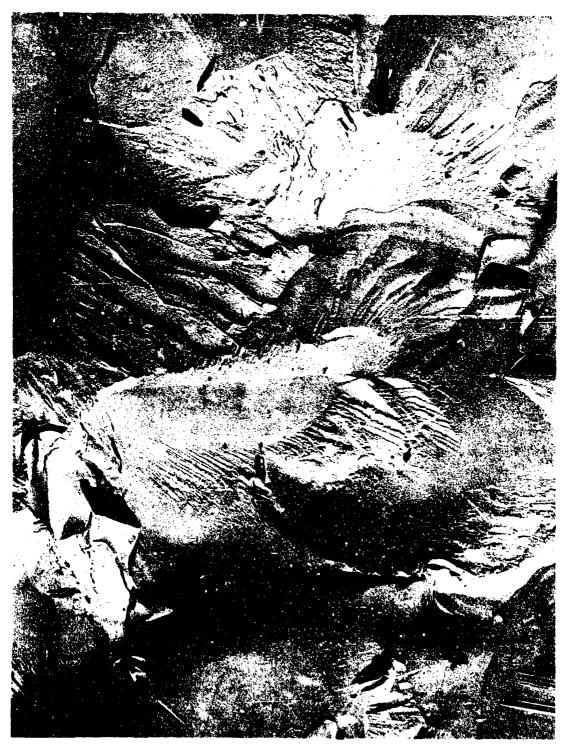
Figure 16. Fracture fragments and transition from intergranular separation to transgranular fracture on a smoothly textured portion of a radial crack in ballistically damaged polycrystalline alumina tile, X9,600.

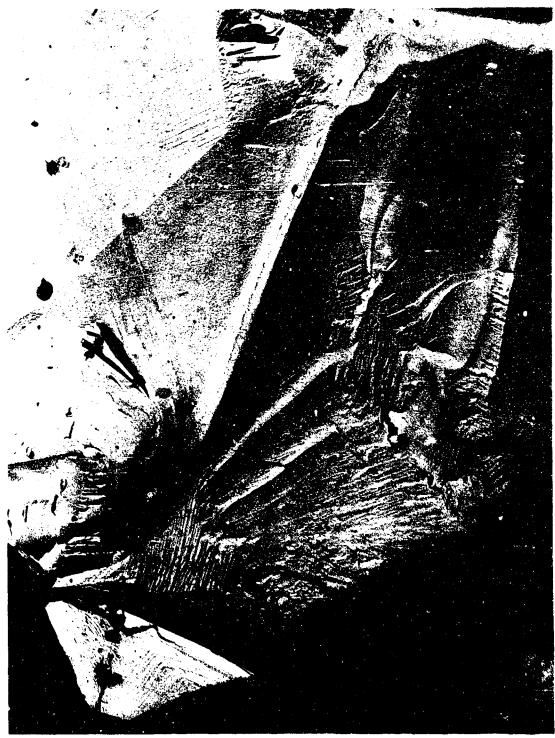
Figure 17. Transition from intergranular separation to transgranular fracture along grain edge junction on a radial crack surface in ballistically damaged polycrystalline alumina tile, X9,600.

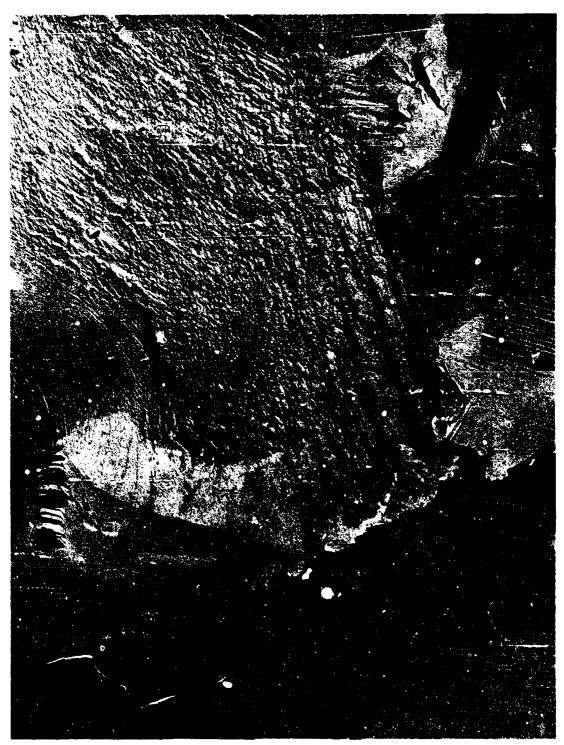
Figure 18. Fracture textures on transverse secondary crack in ballistically damaged polycrystalline alumina tile, X9,600.
Two stage plastic-carbon replica, Pt-shadowed at 30° [SD5-402].

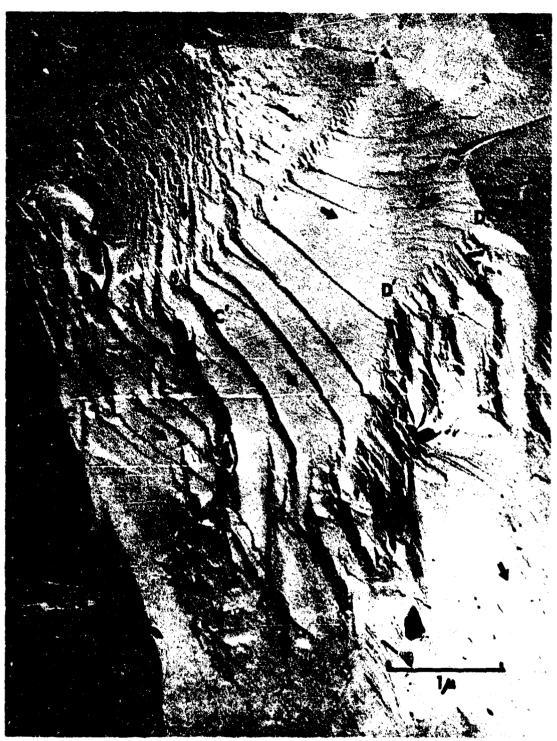
At the higher magnification of this surface provided by Figure 19, there are several interesting examples of interactions between the advancing crack and the crystalline substructure (principally subgrain boundaries). These interactions apparently result in very local alterations of the fracture texture, as noted by Low. 68

Figure 19. River pattern cleavage steps on transverse secondary crack in ballistically damaged polycrystalline alumina tile, X31,200. Two stage plastic-carbon replica, Pt-shadowed at 30° [SD5-391]. Multiplications and redirections occur at the grain boundary marked by line A-A'; other changes along B-B', C-C', D-D', D-D', and B'-D' may be indicative of the influence of subgrain broundaries. Arrows indicate local directions of advancing crack.

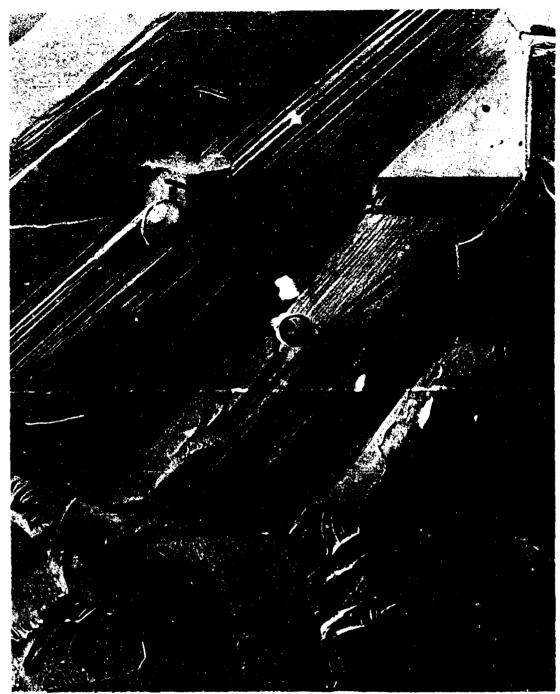
Figure 20. Interactions between cleavage cracks and microstructural features on transverse secondary crack surface in ballistically damaged polycrystalline alumina tile, X9,600.

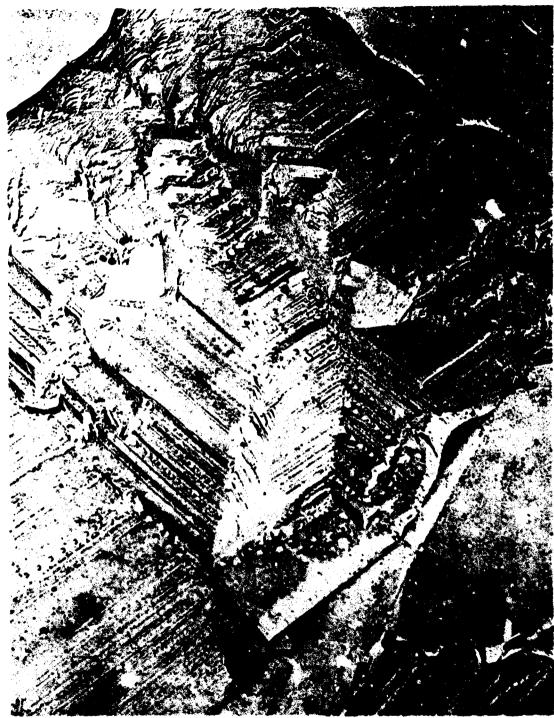
Figure 22. Transgranular cleavage fracture on late-phase spall crack surface in ballistically damaged polycrystalline alumina tile, X21,500.

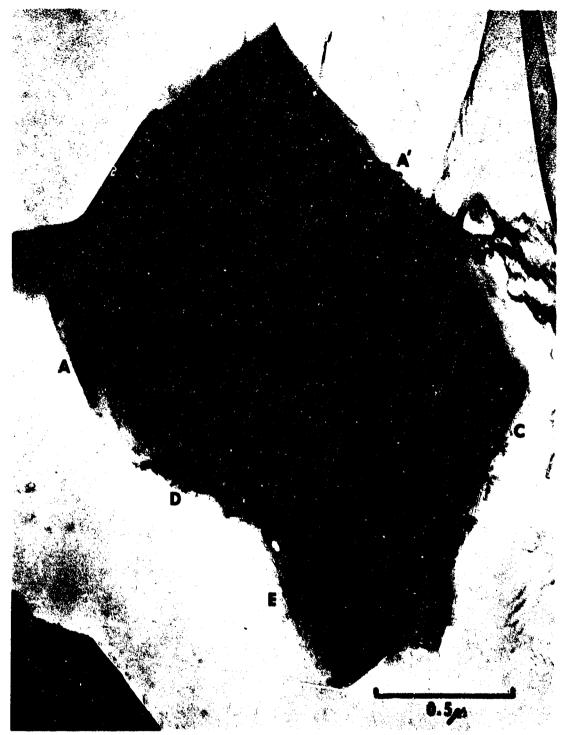
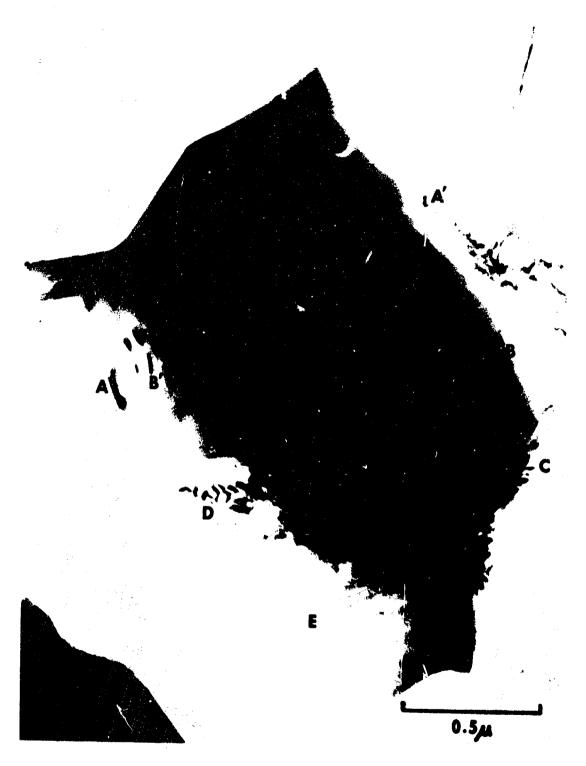
Thickness variations in this specimen create many problems in providing adequate photographic contrast for the details of interest. Figures 25a and 25b were enlarged from the same plate, under different contrast conditions. Contrast in Figure 25a has been adjusted to resolve the edge details, but has been shifted in Figure 25b (and in subsequent Figures) to emphasize the interior dislocations.

a. Photographic contrast adjusted to reveal edge details.

b. Photographic contrast adjusted to reveal interior dislocations. Figure 25, continued.

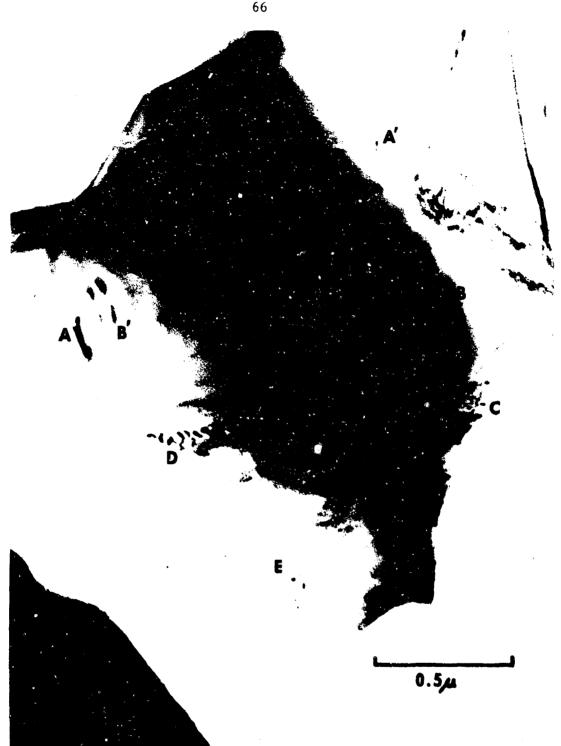
Figure 26. Same fragment, tilted to slightly different orientation to achieve stronger contrast on interior dislocations, X75,000. Extracted fragment on plastic-carbon replica, Pt-shadowed [D1-1815]. Shifting away from a Bragg diffraction condition (which caused overall darkening in Fig. 25) permits more of the transmitted beam to penetrate good portions of the crystal, thereby enhancing visibility for dislocations along A'-D and C-D. However, those along C-E have lost contrast. Lattice distortions around dislocations can either re-establish or further diminish Bragg diffraction conditions in small adjacent regions. These contrast effects make imaging of dislocations possible.

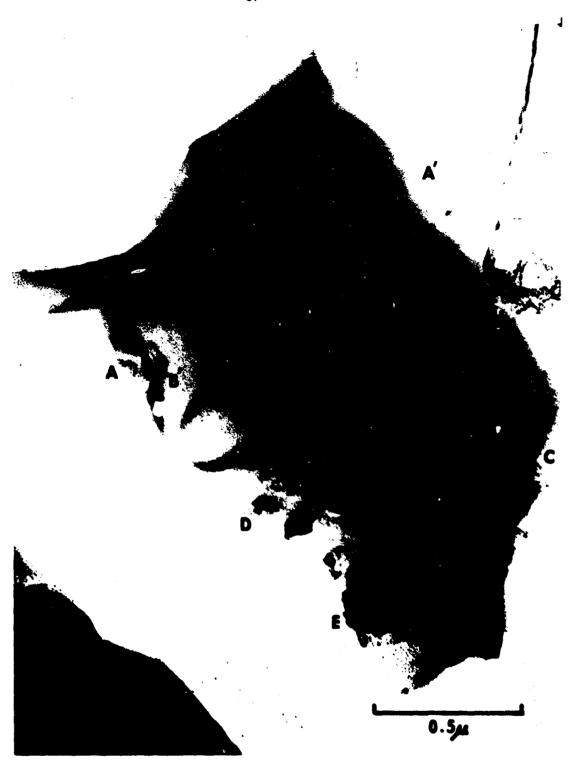
Figure 27. Additional tilting of the fragment (for two beam diffraction) reduces contrast for dislocations previously imaged, but brings a very densely populated region along C-E into strong contrast, X80,000.

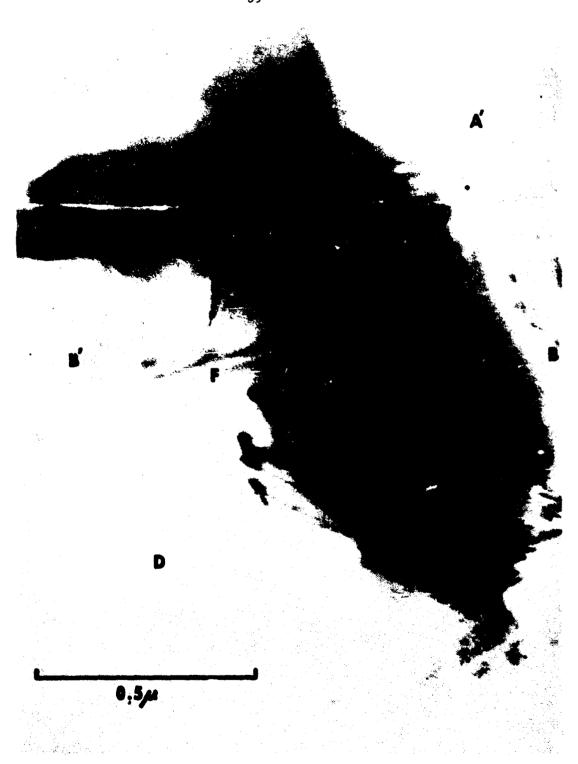
Figure 28 was obtained at higher magnification after the specimen had been tilted to another orientation (a two beam diffraction condition) producing well defined linear traces for dislocations in the A - D and C - D groups, but no contrast for the C - E group. Additional tilting to another two beam diffraction condition yielded the bright field image shown in Figure 29, in which the A, A', B, B' dislocations have no contrast, while those along A' - D, C - D, and at F have weak contrast, appearing as single lines.

Figure 28. Another two beam diffraction case provides additional detail of A'-D and C-D dislocations in thickest portion of fragment, X120,000.

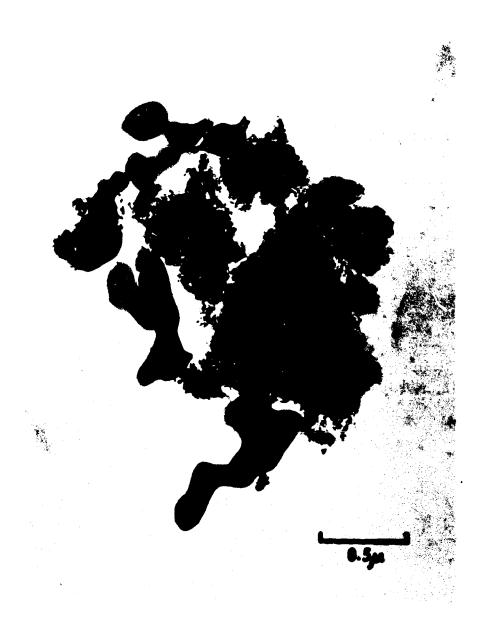
Figure 34. Linde A alumina powder as received, X60,000.

The control material (Fig. 34) contains two phases. The dominant $\alpha-Al_2O_3$ final product has irregular, rounded, often protuberant shapes, while the intermediate, metastable $\gamma-Al_2O_3$ minor phase is extremely fine grained and flocky.*

Deposited on carbon support film as ultrasonically agitated suspension in acetone [PDQ2-1399].

This is the unshocked control material. Compare with explosively shocked Linde A in Fig. 35.
